# Upminster Windmill

Newsletter March 2017

## Dennis Reports

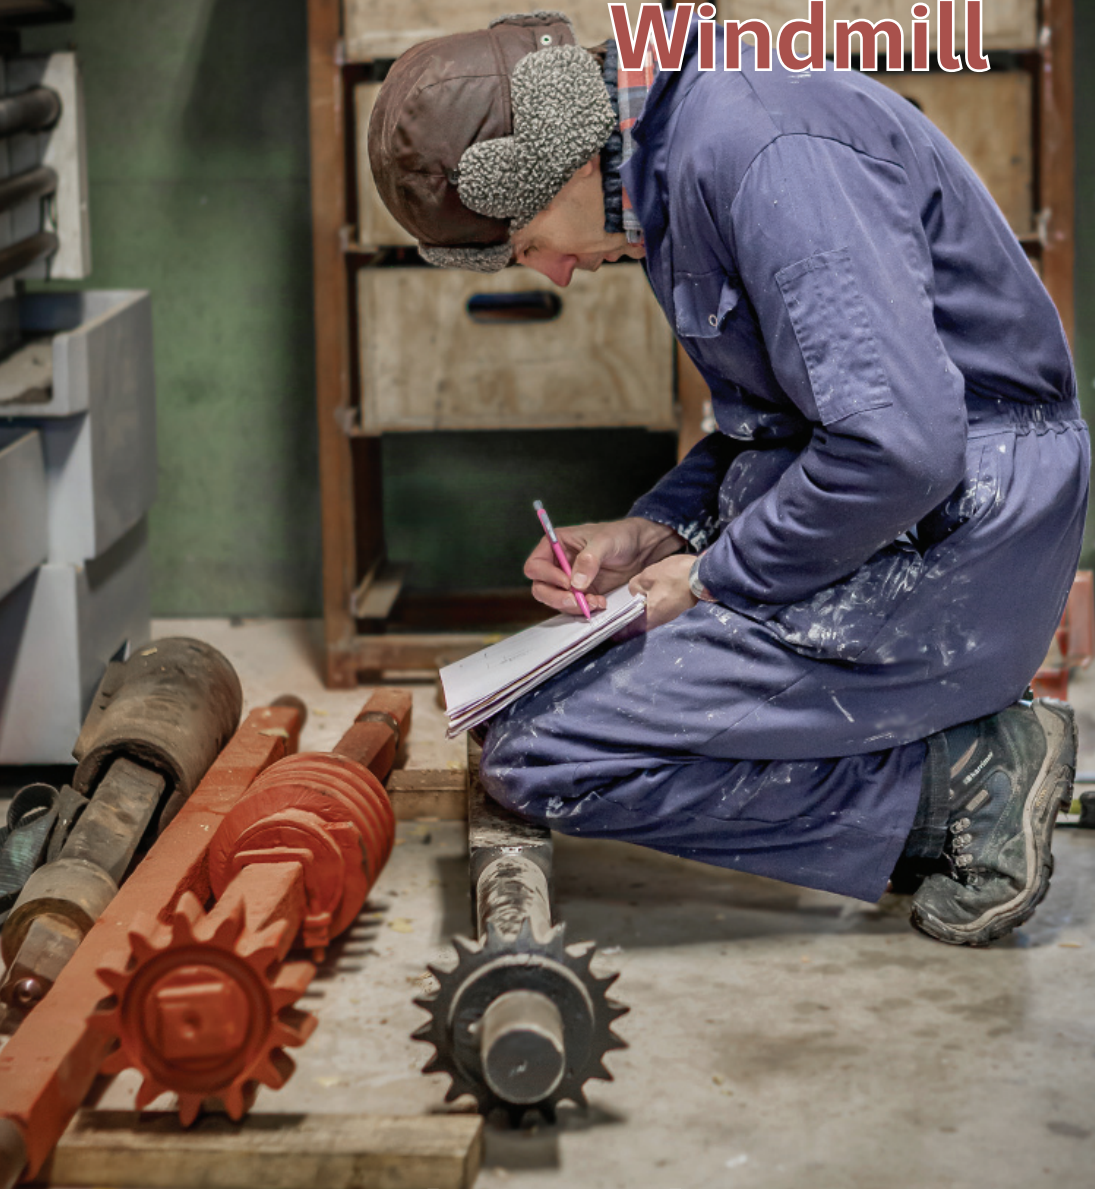
Our cover picture shows Luke taking careful measurements of some of the Mill's components. The combination of Luke's recording and Andrew's photography enable an accurate historical record to be compiled, while simultaneously enabling Clifford and Jonathan to continue their electronic modelling. Clifford's separate article shows how the data from Luke and Andrew during their visit to Holland has enabled him to draw a wonderful exploded diagram of the parts of the cap-frame.

**© Published by the Friends of Upminster Windmill  
Registered Charity Number 1162180  
Front cover: Luke Bonwick recording details of mill parts.  
Cover photograph by Andrew Conway**

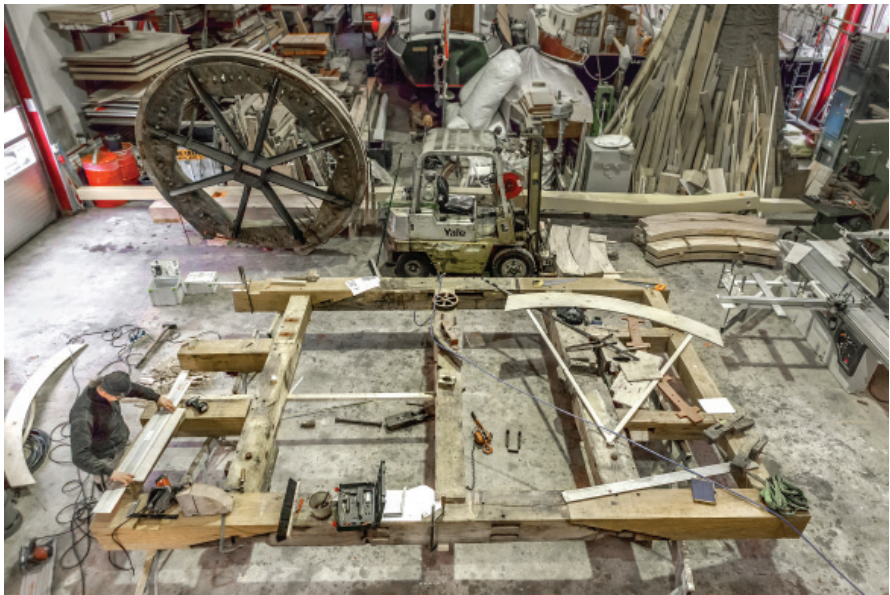
We were all impressed by the quality of the work and the progress made. Image 1 shows Willem (our millwright) working on the frame of the mill's cap. Our large brakewheel, yet to be refurbished, can also be seen.

***1. Cap frame during repair.***

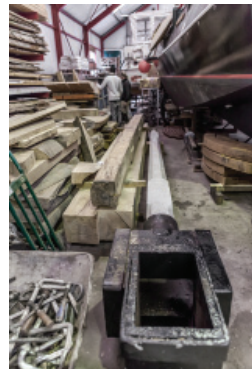
The windshaft has been blast-cleaned, its neck and tail journals have been re-machined, the external parts galvanised and the shaft as a whole redecorated.

***2. Cleaned and renovated windshaft.***

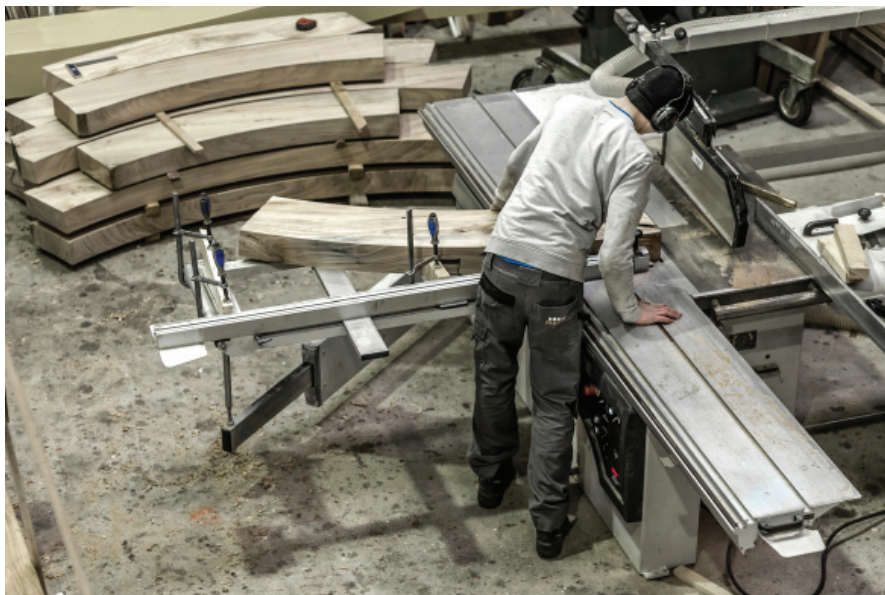
It was not possible to obtain well seasoned elm in wide slabs of sufficient thickness to accommodate the required curvature of the segments of the curb. Each curved segment will therefore be made from two laminates glued and pegged together. Image 3 shows Willem's assistant, Douwe, machining one of the segments. More segments can be seen in the background.

***3. A curb section being machined.***

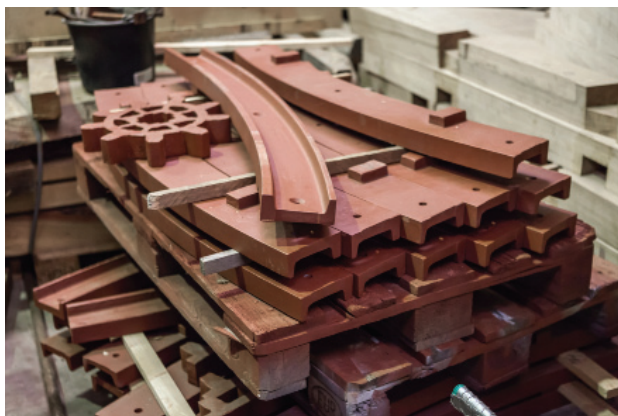
The metal components of the curb have been repaired or recast and are ready for assembly. The sections of the upper curb channel have been shot-blasted and redecorated and are reusable. The lower curb channel sections were beyond repair and have been replaced. The curb rack (the toothed section) has also been refurbished, together with the nine-toothed drive pinion. The illustration shows a number of curb track

***4. Curb track channels.***

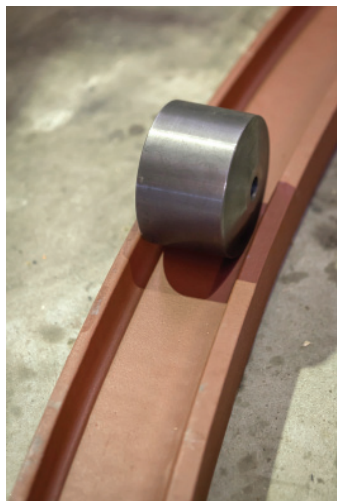
channel castings. One ring of segments will be fixed to the elm curb timbers and a second ring will be fitted to the oak track circle below the underside of the cap frame. Thirty new cap rollers have also been cast. These will sit between the upper and lower curb channels, enabling the cap's rotation. Both the rollers and the track channels have slightly tapered surfaces, recognising the increased diameter of the Mill caused by the width of the track. For each full rotation of the cap, the outside of the roller travels seventeen inches further than the nearside. An example of a cap roller within a lower curb channel is illustrated.

### ***5. Curb channel and roller.***

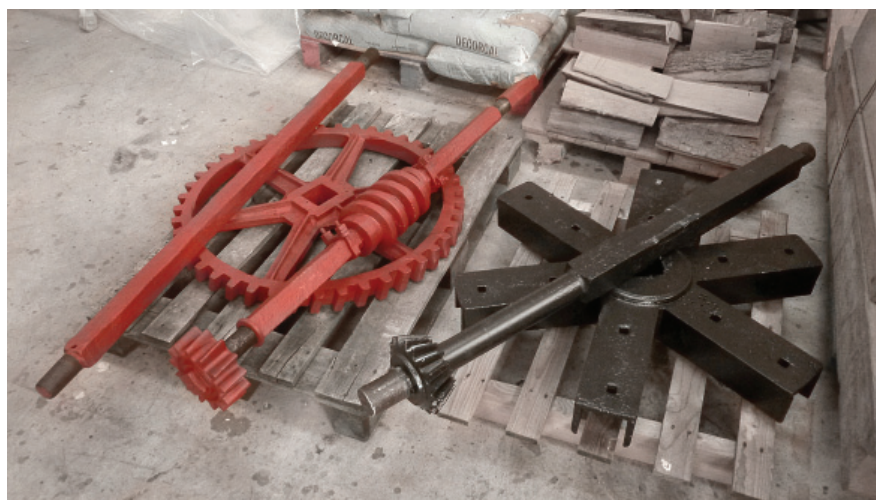
Other work has included the refurbishment of the metal parts of the fantail driving mechanism. The hub and spindle have been blast-cleaned, spray-galvanised and decorated with two coats of black epoxy paint. The down shaft and reduction gears have been blast-cleaned and redecorated with red lead oxide paint. Some of these parts can be seen in the following illustration.

### ***6. Fantail spindle and hub, and parts of the drive mechanism.***

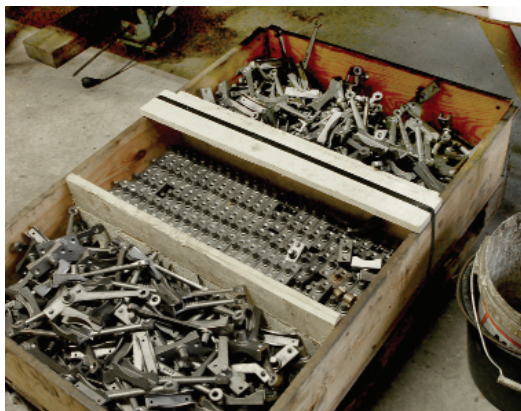
The new metalwork for the shutters has also been cast and drilling and decorating is now in progress. A set of 576 new bronze thimbles (bushes) has been cast for the patent sails. These will be let into the side members of the sail frames to accommodate the pivot pins of each shutter hinge. A protruding rib on the outside of the thimble ensures it cannot rotate in its timber housing. New pivots (hinges) have also been cast, 288 plain, and 288 with shutter cranks (levers) incorporated, as seen in image 7.

***7. Shutter hinges, plain and with levers.***

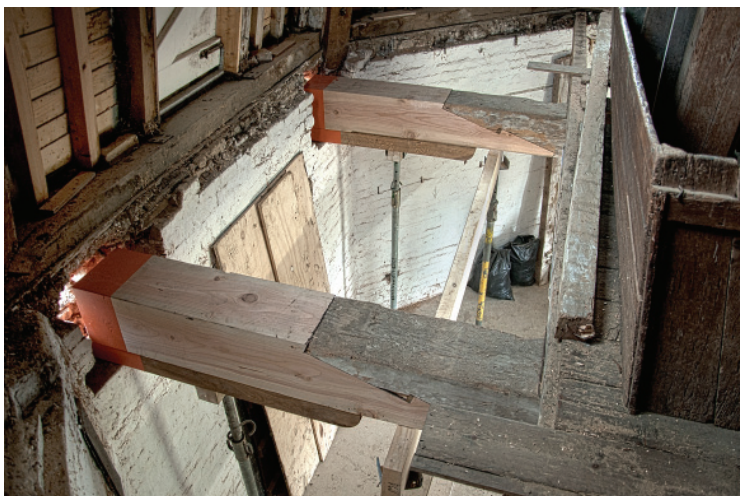
Meanwhile, work has also been progressing on the site at Upminster. Exposure of the ends of the two beams supporting the first floor showed severe deterioration where the beams were nestled in the brickwork. Willem has constructed four new ends, two of which have been scarfed successfully into position, as shown in image 8.

***8. Scarfed ends of the sheer beams that support the Meal Floor***

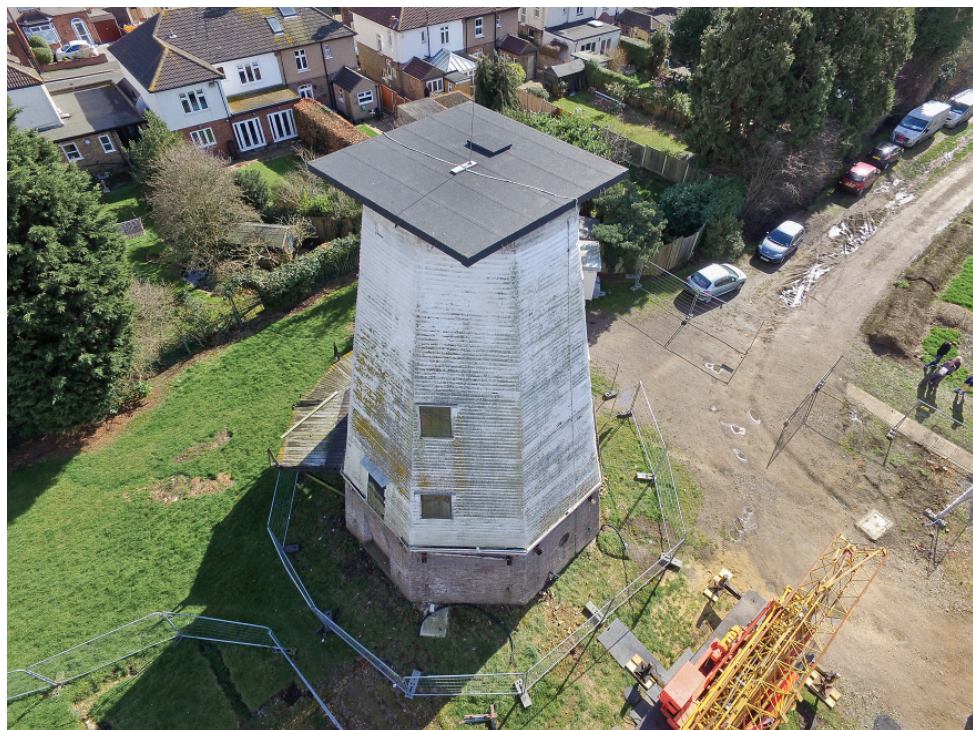
Work is also underway on the removal of the external first floor gallery, which image 9 shows is now mostly demolished. A walk around the gallery was once an exciting element of our guided tours but was stopped many years ago when the structure became unsafe.

***9. The reefing gallery. Most has been demolished.***

The Mill looks very sad now, though that is an inevitable phase of the project. Willem expects to fit the remaining beam-ends and finish the demolition of the gallery in April. The following month will see the scaffold erected and the start of the tower repairs.

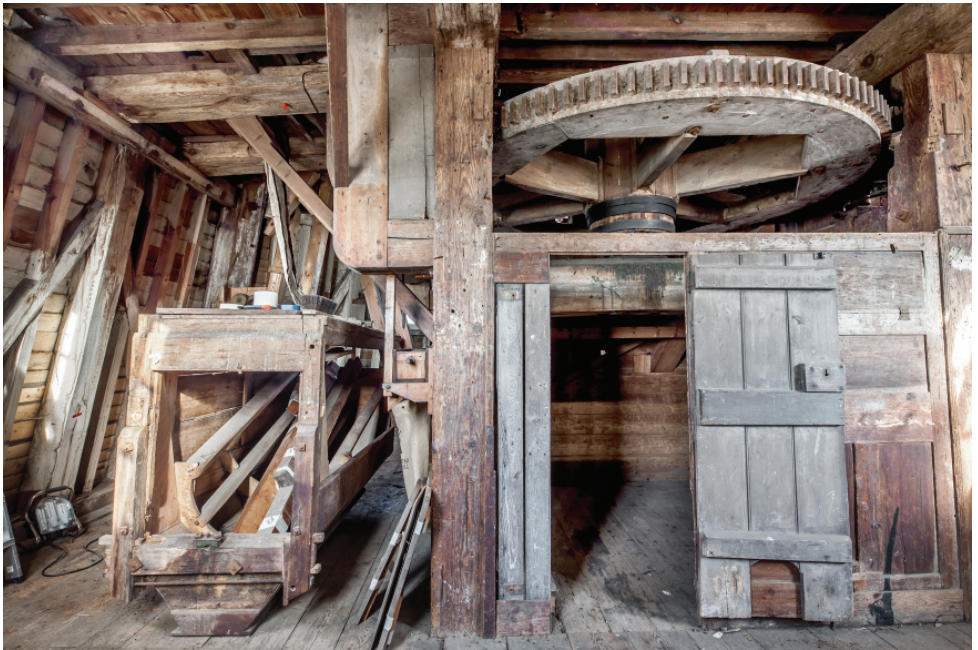
The major machinery removed comprised the Sack Hoist, Wire Machine and Bolter. Each piece was photographed and carefully measured as to its position within the Mill. The pieces were labelled and are now carefully stored ready for the team to start refurbishment later this year.

***Bolter on the Meal Floor moved away from the wall***

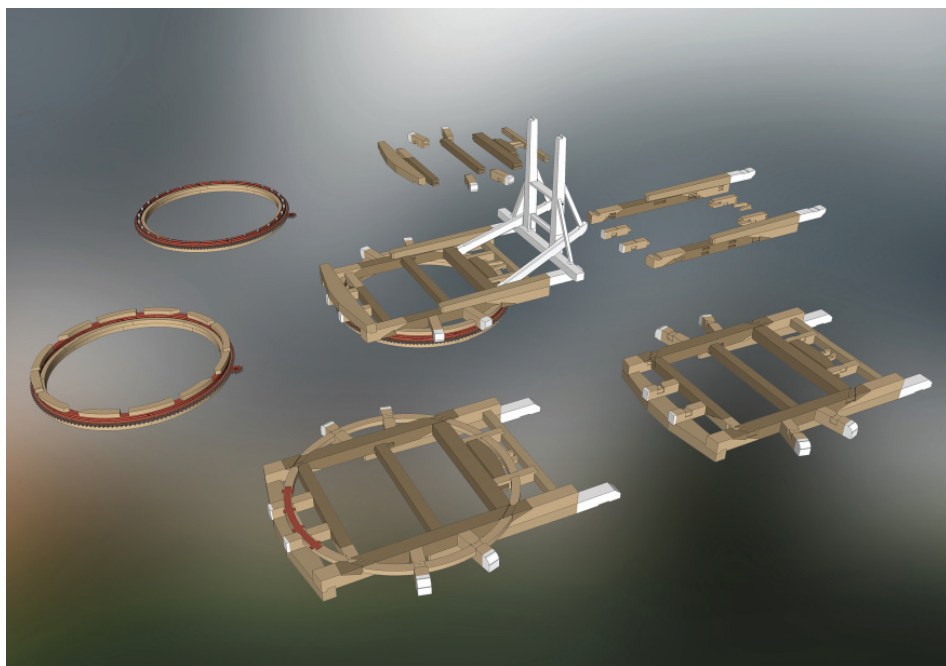
The recording and accurate drafting is at an early stage, at present concentrating on the cap and fantail, both of which are complex structures. Below is an exploded view taken from the new 3D model being drawn to the dimensions extracted during restoration.

In the image above, the two foreground views of the cap frame have been inverted so you can see the under side.

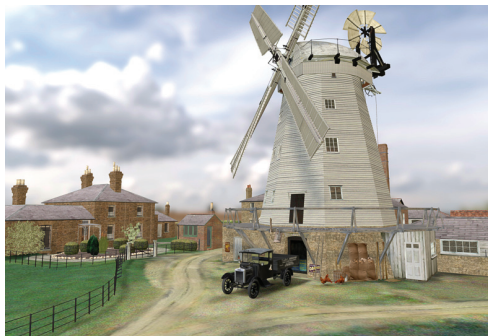
Jonathan Green has continued to refine his photorealistic 3D models, most notably his models *Upminster Windmill in the 1920's*, and *Upminster Windmill Full Model*. Both of these he has annotated, and in the case of the 1920's model the annotations can be used as an aid to take a tour around the mill site.

***The 1920's model of the mill site***

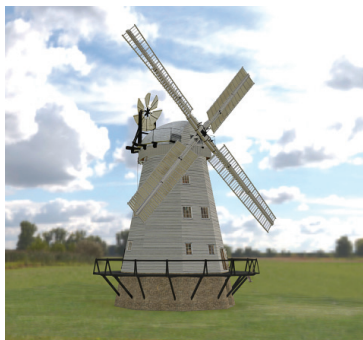
***Model of the full mill***
