UPMINSTER WINDMILL HERITAGE SITE
ARCHAEOLOGICAL EXCAVATIONS REPORT

UPMINSTER MILLS COMPLEX

Excavations undertaken from May 2011 to
November 2015 on behalf of the Friends of
Upminster Windmill

Report Ref No MRL 16/UMC

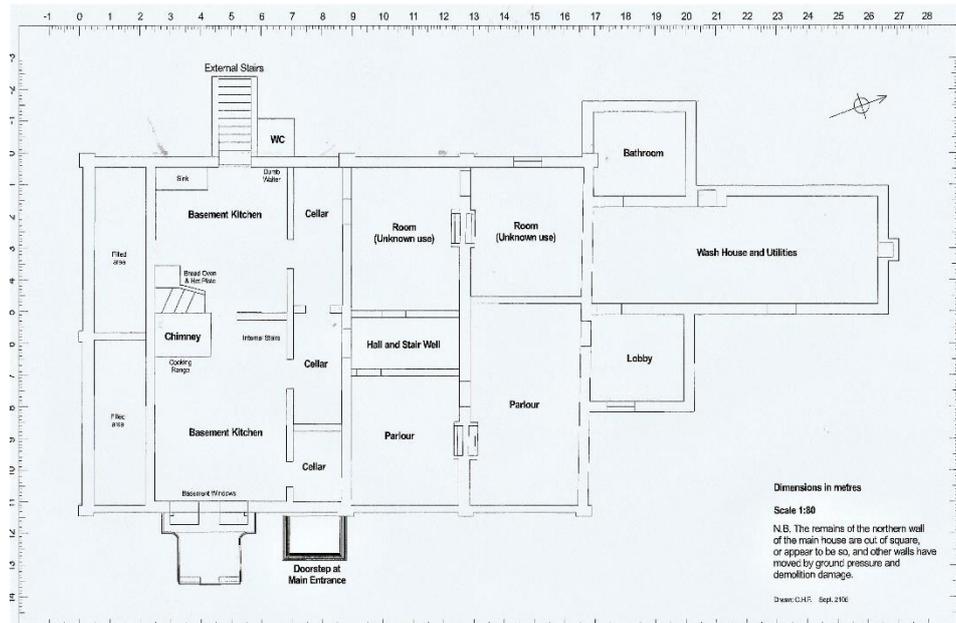
Fig 5

Upon excavation, the foundation walls were found intact which gave us a footprint of the building (Figs 4 & 5), although some internal features were open for discussion. The perimeter walls and central load bearing walls were 14 inches (35.5 cm) wide and internal walls that remain were 9 inches (22.8 cm) wide. The foundation walls of the building were stepped out over 3 courses from 14 inches (35.5 cm) to 21 inches (53.3 cm) and sat on a bed of clay. The brickwork was of Flemish bond and consisted of red bricks (220mm x 95mm x 65mm) and yellow bricks (224mm x 107mm x 65mm) bonded with lime mortar.

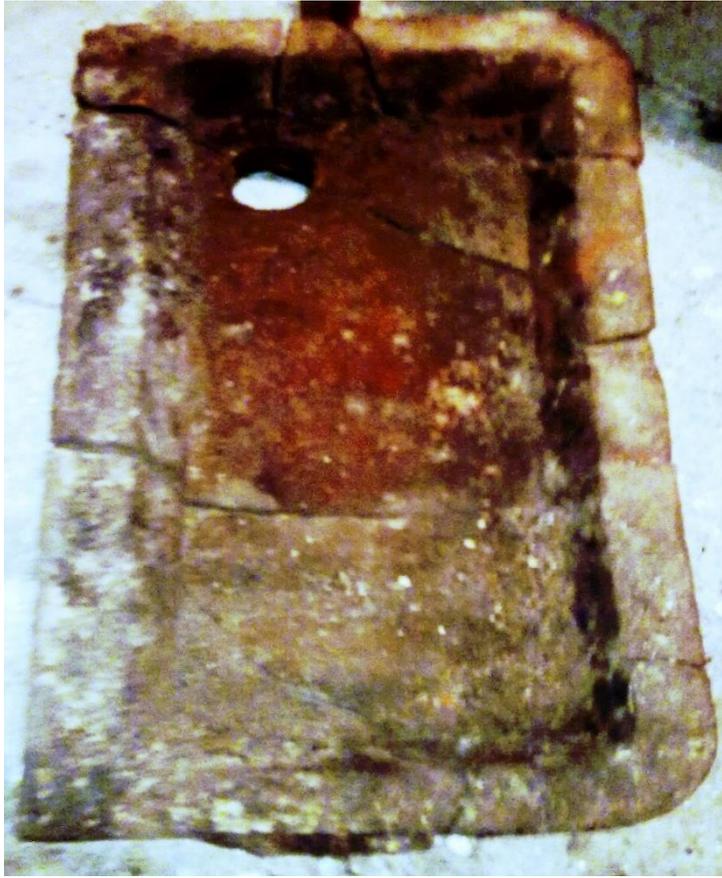
Fig 15 Sandstone sink

A shallow sandstone sink (known as an “arms sink” - *for the washing of hands/arms after pastry making*) (Fig 15) was still in situ on its brick piers against the west wall beside the stairs. This was complete although broken due to the weight of the demolition rubble on top of it. The drain for the sink was still in situ in the floor, the wastewater from the sink being allowed to run

6.9 Stone: Apart from the sandstone door lintels and hearths, as mentioned earlier, the only other pieces of worked stone found to date were a couple of stone orbs, (Fig 14) 3 inches (8 cm) diameter - they had a hole drilled through the centre of each; these could have been used as counterbalance weights possibly for a dumb waiter in the basement kitchen. There was also a shallow sandstone sink (Fig 15).

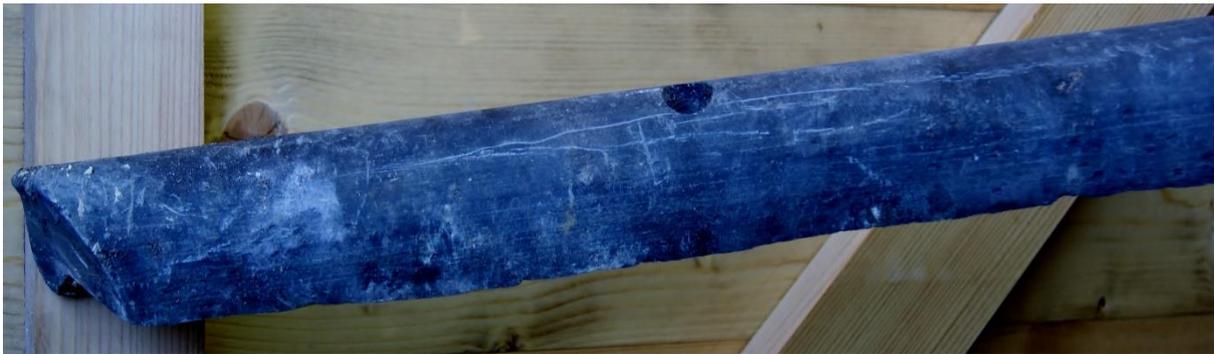
19 Slate capping

The roof consisted of Welsh slate tiles and slate cappings (Figs 19 & 19a). The roof was of shallow pitch and hipped on the northern part of the house. The roof on the southern half of the house was shallow pitched and 'u' shaped. The guttering was of cast iron square profile with round downpipes. The overall dimension of the building was 56 feet (17.5m) north to south and 37 feet (11.26m) east to west.

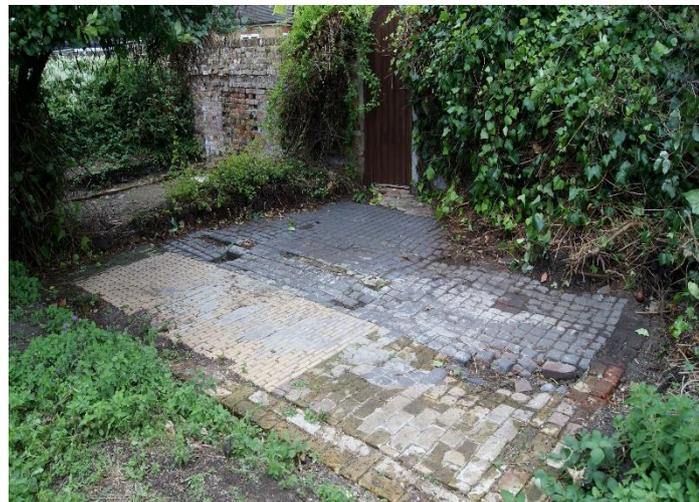
The two storey **Stable Building** (fig 37) still had its cobbled floor in situ including the postholes where the stall partitions would have been located. There were three stalls, each one approx. 5 feet 7 inches (1.69m) wide.

There were two floor drains in situ and the pipework ran back to the main drain at the rear of the mill cottages.

The stalls area measured 11 feet 4 inches (3.45m) north to south and 16 feet 9.5 inches (5.1m) east to west. The tacking up area still had its flooring intact, this was south of the stalls, at the front of the stable block. This area measured 4 feet 7 inches (1.4m) north to south 16 feet 9.5 inches east to west. There was no archaeological evidence of the upper hayloft or mangers.

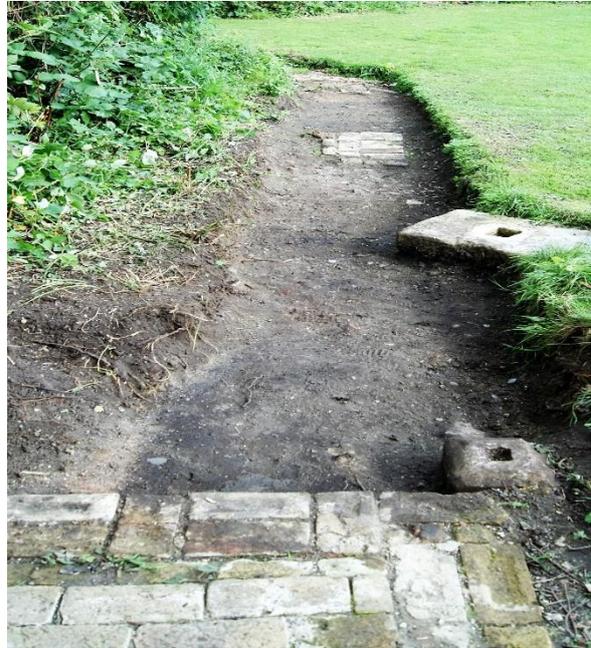
Fig 38

The **Cart Shed** (fig 38) was a single storey four-sided brick building measuring 15 feet 11 inches (4.85m) north to south and 23 feet 5 inches (7.12m) east to west. The front wall ran from the east wall westwards for a distance of 11 feet 3 inches (3.42m). The brick pillar supporting the west end of this wall was 2 feet (.61m) square. The entrance was 12 feet 2 inches (3.69m) and would have required 2 wooden gates of 6 feet (1.83m) wide to span the front of the building. The flooring we think was cobbled, as far as we could excavate. There were two large stone blocks at either end at the front of the building, both with sizeable holes in the centre, which we believe held the large door posts.

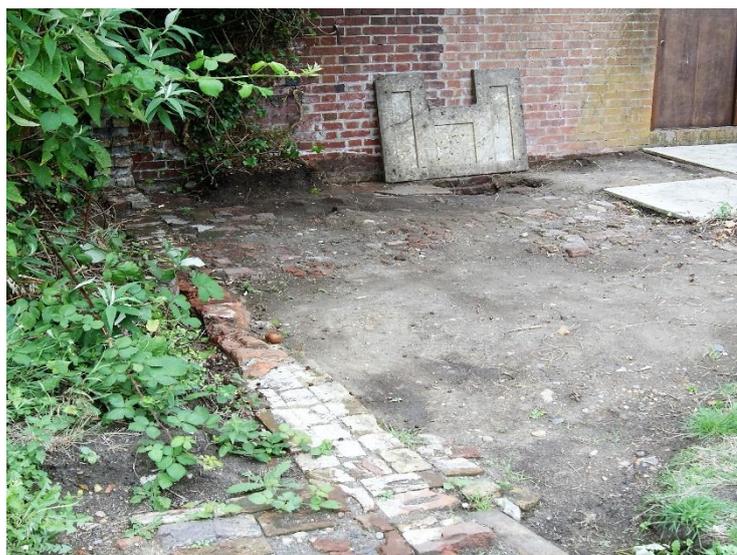
Fig 39

The **Lean-to** (fig 39) at the eastern end of the building was a timber framed lean-to, open on two sides. Upon excavation, a brick floor was uncovered, measuring 7 feet 11 inches (2.4m) north to south and 8 feet 7 inches (2.6m) east to west. After further excavations a brick lined pit of 18 inches (46cm) x 15 inches (38cm) x 15 inches (38cm) deep was uncovered, located against the back (north) wall. This may have been lead lined to hold water.

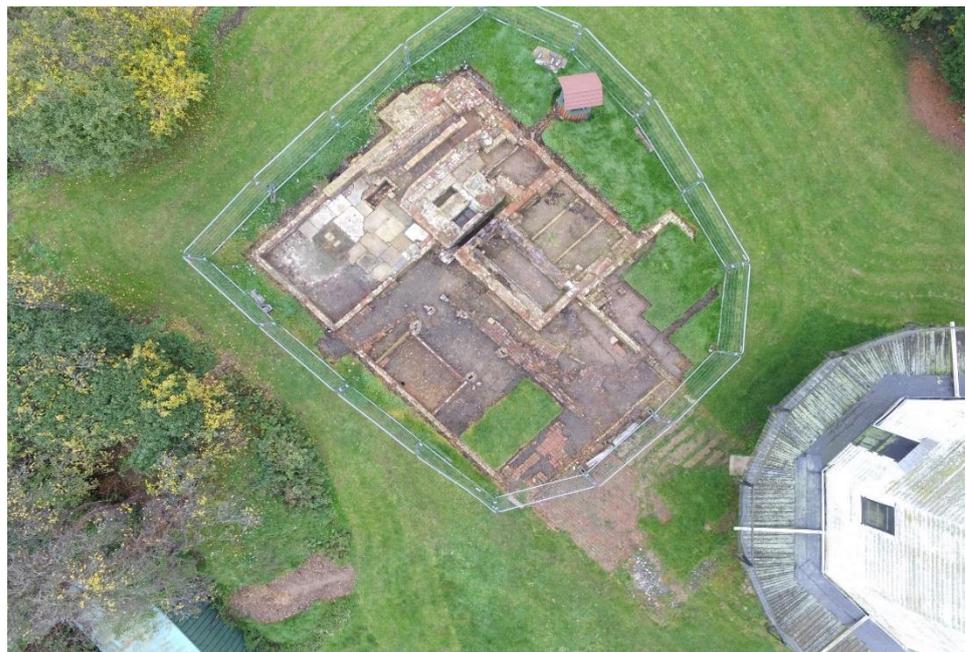
Fig 51 Steam Mill Site.

Upon excavation, the foundation walls were found intact which gave us a footprint of the buildings (Fig 51 & 52).

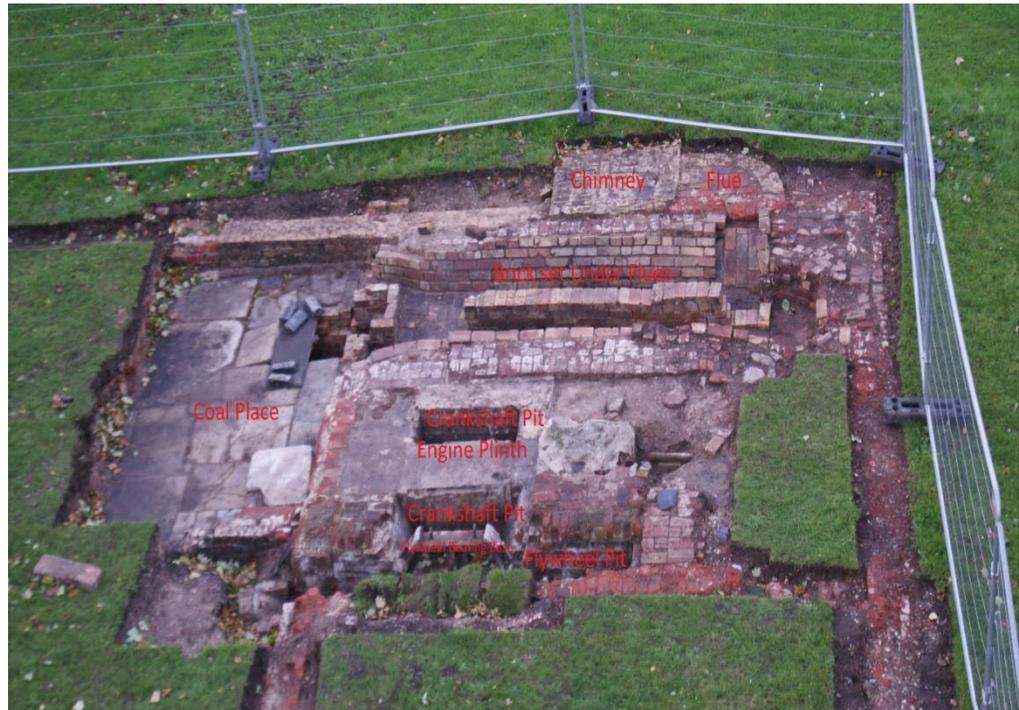
Fig 52
Steam Mill
annotated

The **Grinding Room's** external north-south foundation walls are 17 inches (43cm) wide, and the north wall adjoining the Engine House is 14.5 inches (36cm) wide. There was a wall running north south, dividing the grinding room into two sections. This wall is 18 inches (50cm) wide, the area to the west of this wall was the pit (Fig 54) which housed the drive shafts and cogs. This pit was 17 inches (43cm) wide and 13 inches (33cm) deep and ran the full length of the Grinding Room. The pit walls were of brick which were stepped inwards to the brick floor, giving a "U" shaped pit. This was to accommodate the gear wheels which drove the mill stones above. Some of the stepped wall bricks had been chipped away, suggesting alignment issues with the drive shaft. There was a metal grill set into the eastern pit wall, overlain by a stone slab. The pit floor bricks were laid on their edge. There were some timbers in place along the walls of the pit, which were probably the remains of the mezzanine floor that held the mill stones. The red bricks are 5 courses higher than the floor and the bricks each measure 225mm x 110mm x 64mm. On the eastern side of the pit, there were two brick pads, one on the northern end and one on the southern end of this wall. These were probably to accommodate cranes to remove the mill stones for maintenance. The eastern half of the grinding room continued from these pads. This area was 8 feet 9 inches (2.66m) wide and ran the full length of the grinding room. The floor was timber and there was a brick

step in the north-eastern corner. This was probably where the stairs started to access the mezzanine floor.

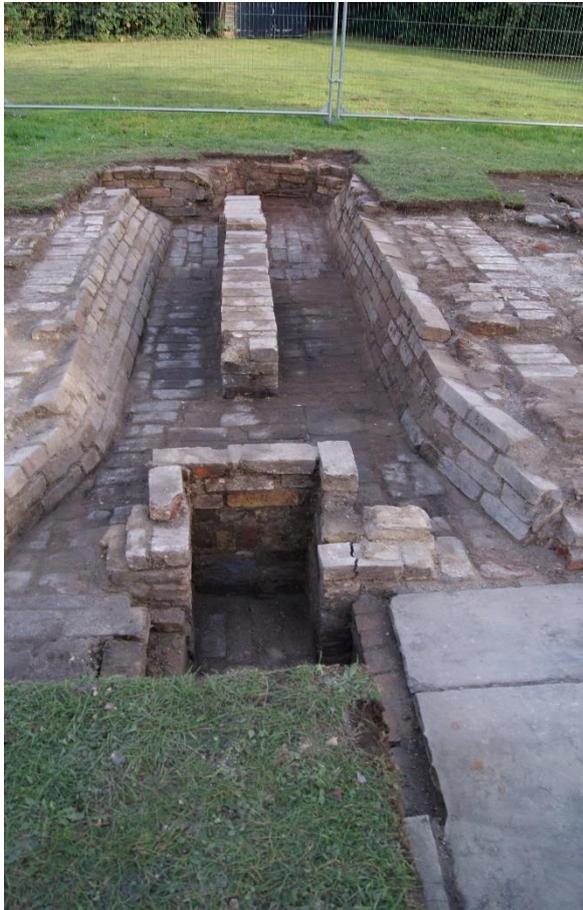
Fig 53 Boiler Flues.

The wall on the north side of the Engine House was a low wall which separated the Engine House from the **Boiler Room**. This wall was 17 feet 9 inches (5.4m) long and 2 feet 1 inch (64cm) wide. The actual height of the wall was unknown, but it was not a full wall from photographs. The boiler flues (Fig 53) ran from east-west in a 'u' shape with splayed openings on the west side. The flues had sloping brick sides and were 2 feet 1 inch (64cm) in depth. The floors were made of firebricks in rows orientated north south. The bricks were replacements and measured 226mm x 108mm x 65mm. The total width of the two flues and central wall being 4 feet 5 inches (1.35m) across the top. The central brick wall between the two flues was 11 feet 2 inches (3.4m) long and 10 inches (25cm) wide, (this wall separated the flues and acted as a support for the boiler). The southern flue was 1 foot 6 inches (44cm) wide at the base and 2 feet 11 inches (88cm) wide at the top. The northern flue was 1 foot 4 inches

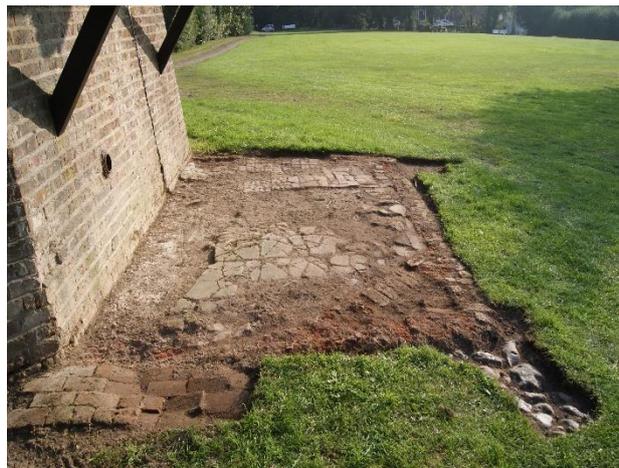
Upon excavation, the foundation walls were mainly intact which gave the footprint of the buildings. The **Hen House** walls (Fig 69) were of 9-inch (22.8cm) construction, and the floor was of brick and sandstone construction. The dimensions of the hen house were 9 feet (2.74m) east-west and 12 feet 6 inches (3.8m) north-south. This was a very simply built outbuilding and was added to the other buildings by 1849.

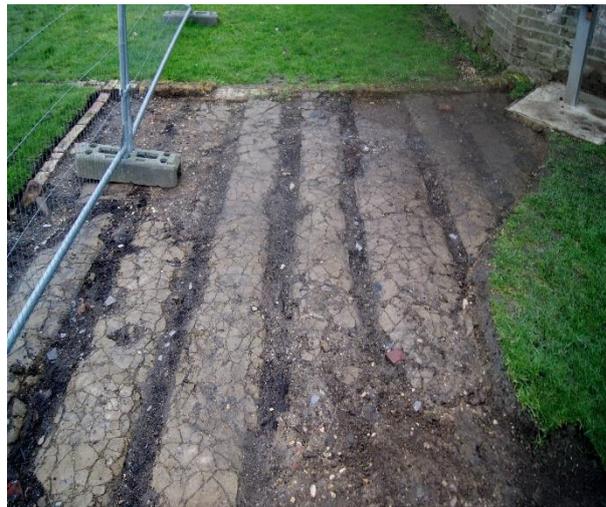
consisted of a series of raised semi-circular mounds, covered in what appears to be limestone (Fig 70). These ran from east to west for the full length of the building. The building measured 23 feet 11 inches (7.28m) north-south and 12 feet 6 inches (3.78m) east-west.

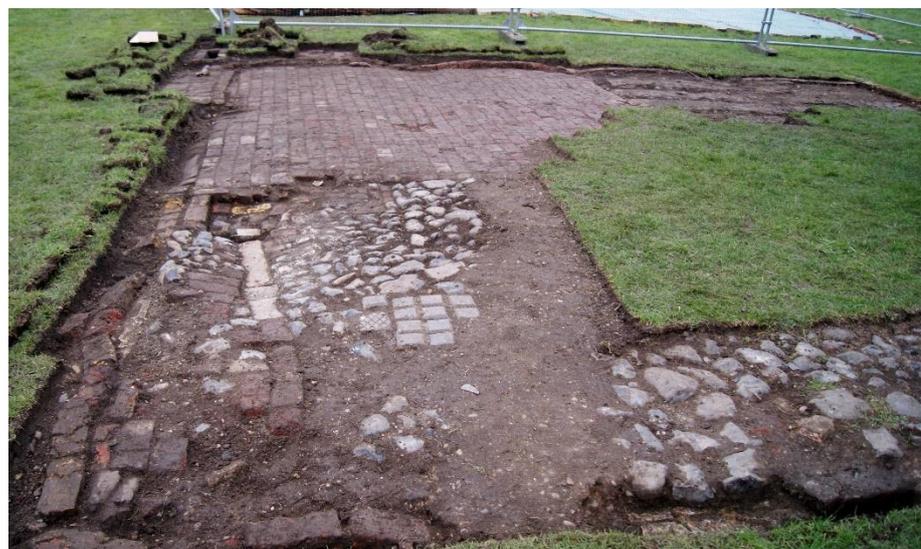
Fig 71

The foundations of the **Old Stables** (Fig 71) were of 9-inch (22.8cm) brick construction. Upon excavation, it indicated that the walls of the old stables and

lumber room were built within the granary 2 building - an indication that

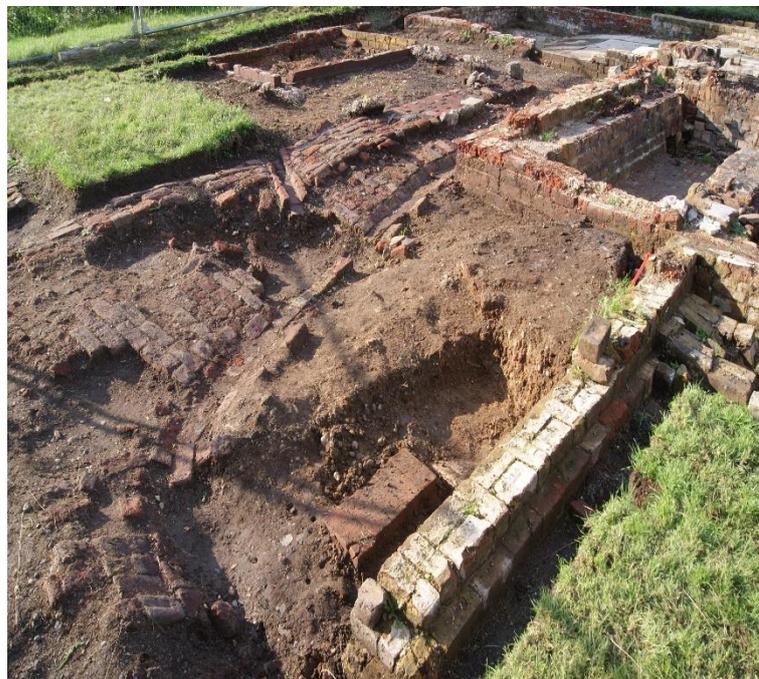
Although the foundations of the **Pig Sty (building)** (Fig 72) was of fairly modern brick construction and measured 9 feet 9 inches (2.96m) north-south and 6 feet 7.5 inches (2.07m) east-west, the **Pig Courts (compound)** were older. The pig sty formed the western boundary of the pig courts and was 6 feet 6.5 inches (1.98m) south of the coal place and 16 feet 6 inches

(5.11m) north of the old stables. There were several concrete blocks in situ which were probably for the pig courts' boundary fence. There was an open brick gully of 1 foot 2 inches (0.35m) wide running north-south along the western side of the steam mill and disappearing under the wall of the meal house; this probably took away rainwater from the roof of the steam plant. There was a brick path running alongside the gully in the same orientation, and this was 3 feet 6 inches (1.05m) wide.
